**RESEARCH ON THE BASIC NATURE OF STRESS CORROSION  
FOR VARIOUS STRUCTURAL ALLOYS AT ROOM AND  
ELEVATED TEMPERATURE**

TECHNICAL REPORT No. ASD-TR-61-713

MAY 1962

(Prepared under Contract No. AF 33(616)-7612  
by Armour Research Foundation, Chicago, Ill.  
Frank A. Crossley, author)

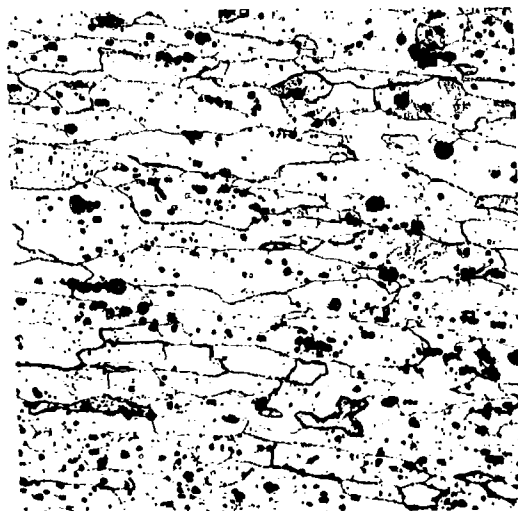
Fig. 1

2024-T86, as-received.

Table 2 summarizes the heat treatments applied to the test materials and the grain size measurements. Representative microstructures are shown in Figs. 1 through 10. Only the 17-7PH in both grain size conditions and the ZK-60A in the as-received condition were equiaxed. Therefore, grain measurements are given in terms of the average dimensions of the major and minor axes of the grains. The microstructure of the cold-rolled and recrystallized B-120VCA alloy (see Fig. 10) was quite varied. Apparently much of the structure recrystallized by secondary recrystallization.

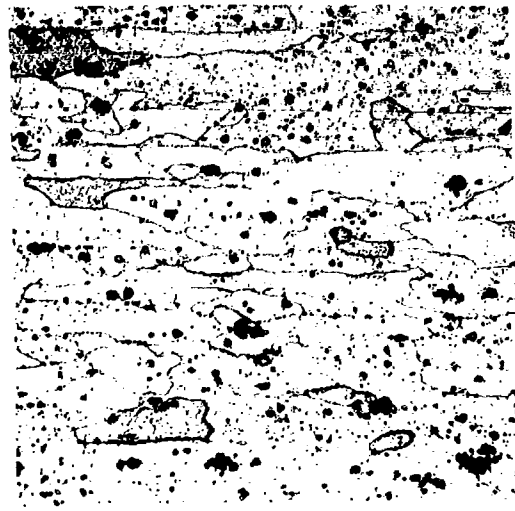
Fig. 2

2024-T86, grain coarsening anneal of  
900°F-30 hr-WQ, cold rolled 6%, aged  
375°F-8 hr-AC.

Etchant: 20% conc. HF, 20% conc. HNO<sub>3</sub>, balance glycerine.

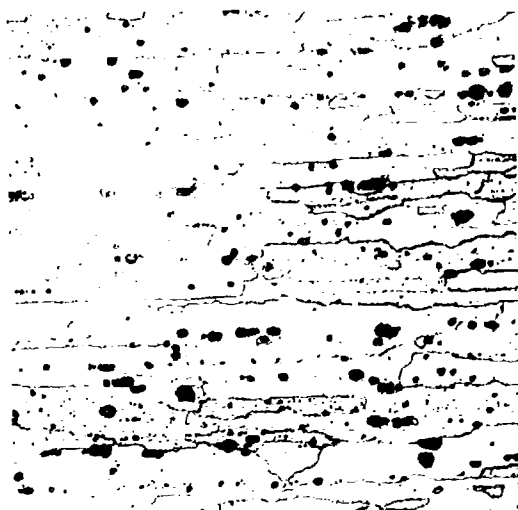
Fig. 3

7075-T6, as-received.

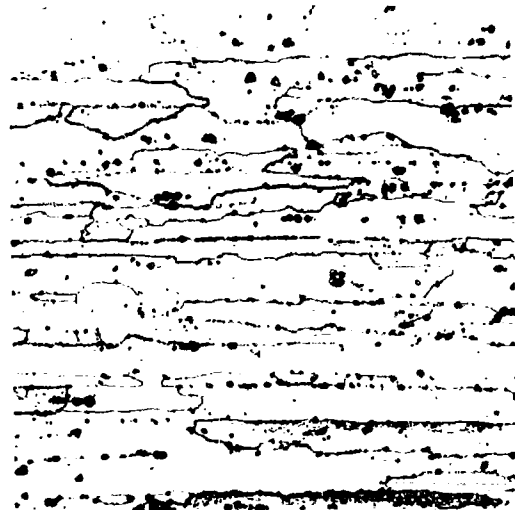
Fig. 4

7075-T6, grain coarsening anneal of  
900°F-30 hr-WQ, aged 250°F-24 hr-AC.

Etchant: Keller's

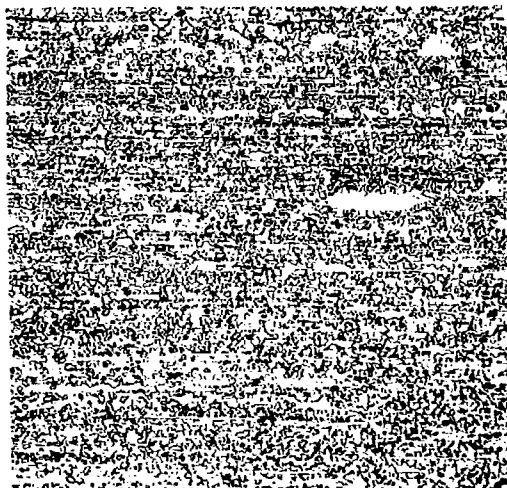
Fig. 5

ZK-60A-T5, as-received.

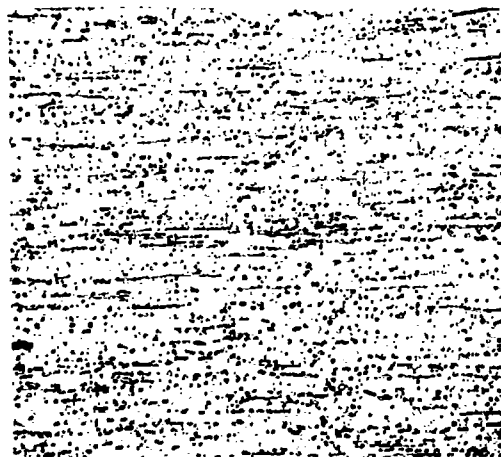
Fig. 7

17-7 PH as-received plus RH 950  
treatment: 1750°F-10 min-AC, -100°F-  
8hr, 950°F-1hr-AC.

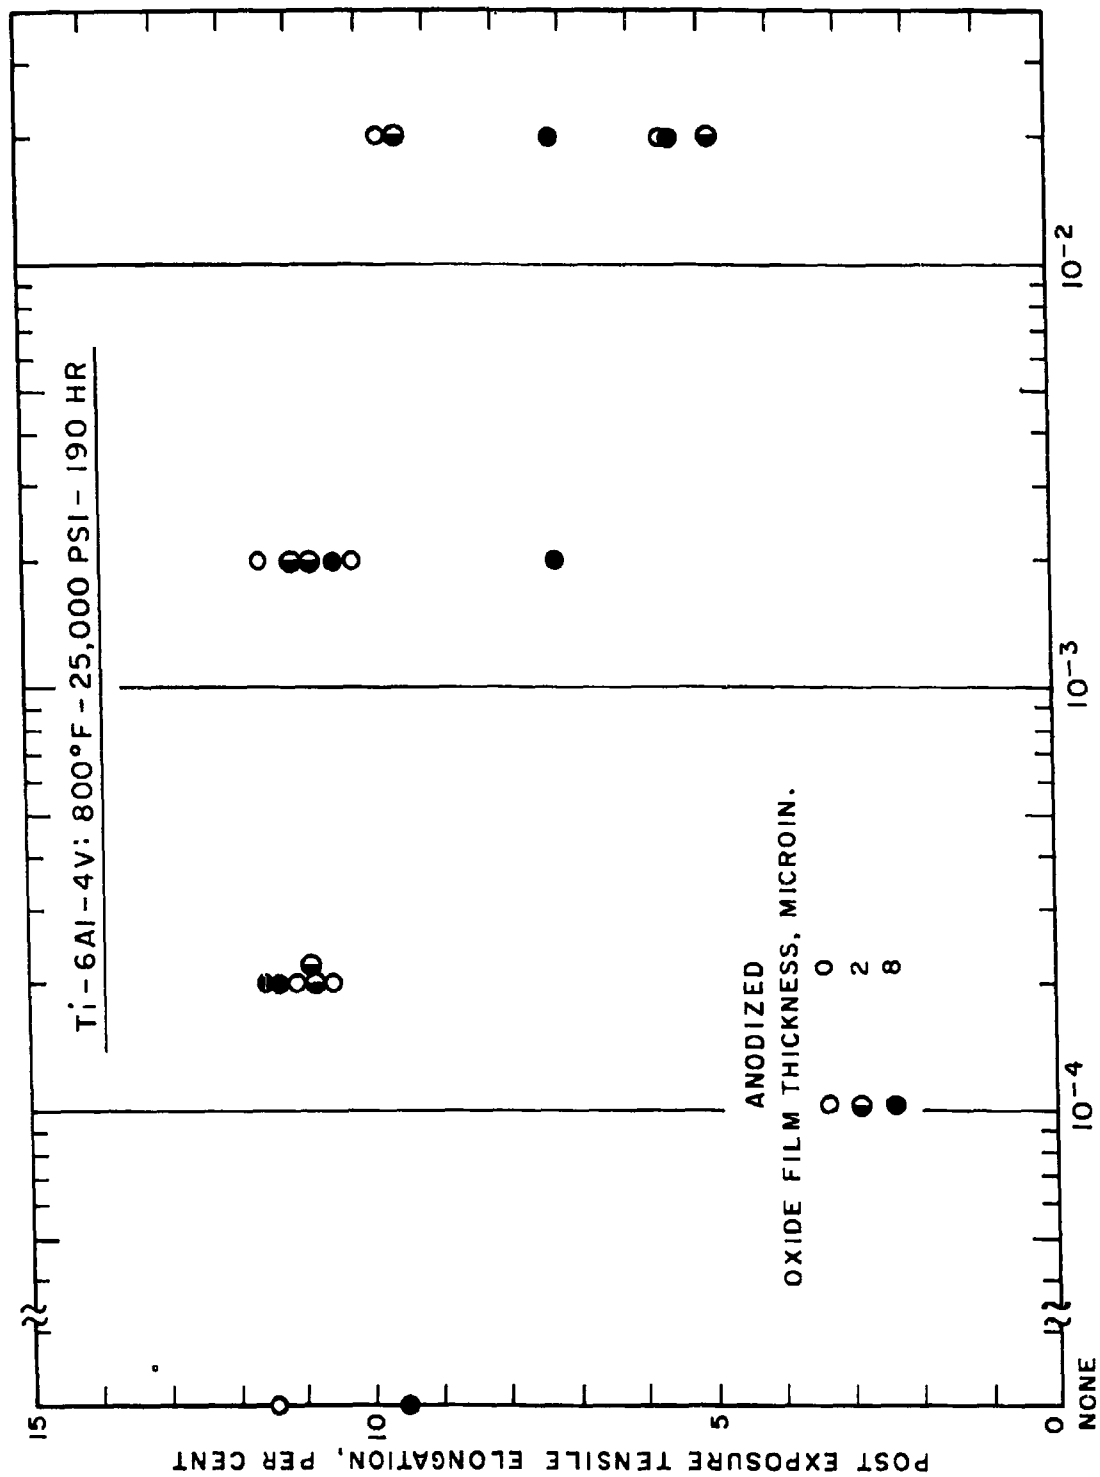
Fig. 11 - Effect of Anodizing and of Salt Concentration on the Stress Corrosion of Ti-6Al-4V Titanium Alloy at 800°F.

All specimens of Ti-6Al-4V and B-120VCA survived the stress-corrosion exposures. A control specimen of Ti-6Al-4V alloy exhibited 0.17% creep under the exposure conditions of 25,000 psi stress at 800°F for 190 hr, while a control specimen of B-120VCA exhibited 0.055% creep under the conditions of 100,000 psi stress at 600°F for 190 hr. Post-exposure tensile properties for the two alloys are given in Tables 3 and 4, respectively. Tensile elongation as an indication of the extent of stress-corrosion damage is plotted in Figs. 11 and 12 versus the salt concentrations on the surface.

The Ti-6Al-4V alloy exhibited significant stress-corrosion effects only at the highest salt level. Anodizing does not appear to have had any effect under these exposure conditions.

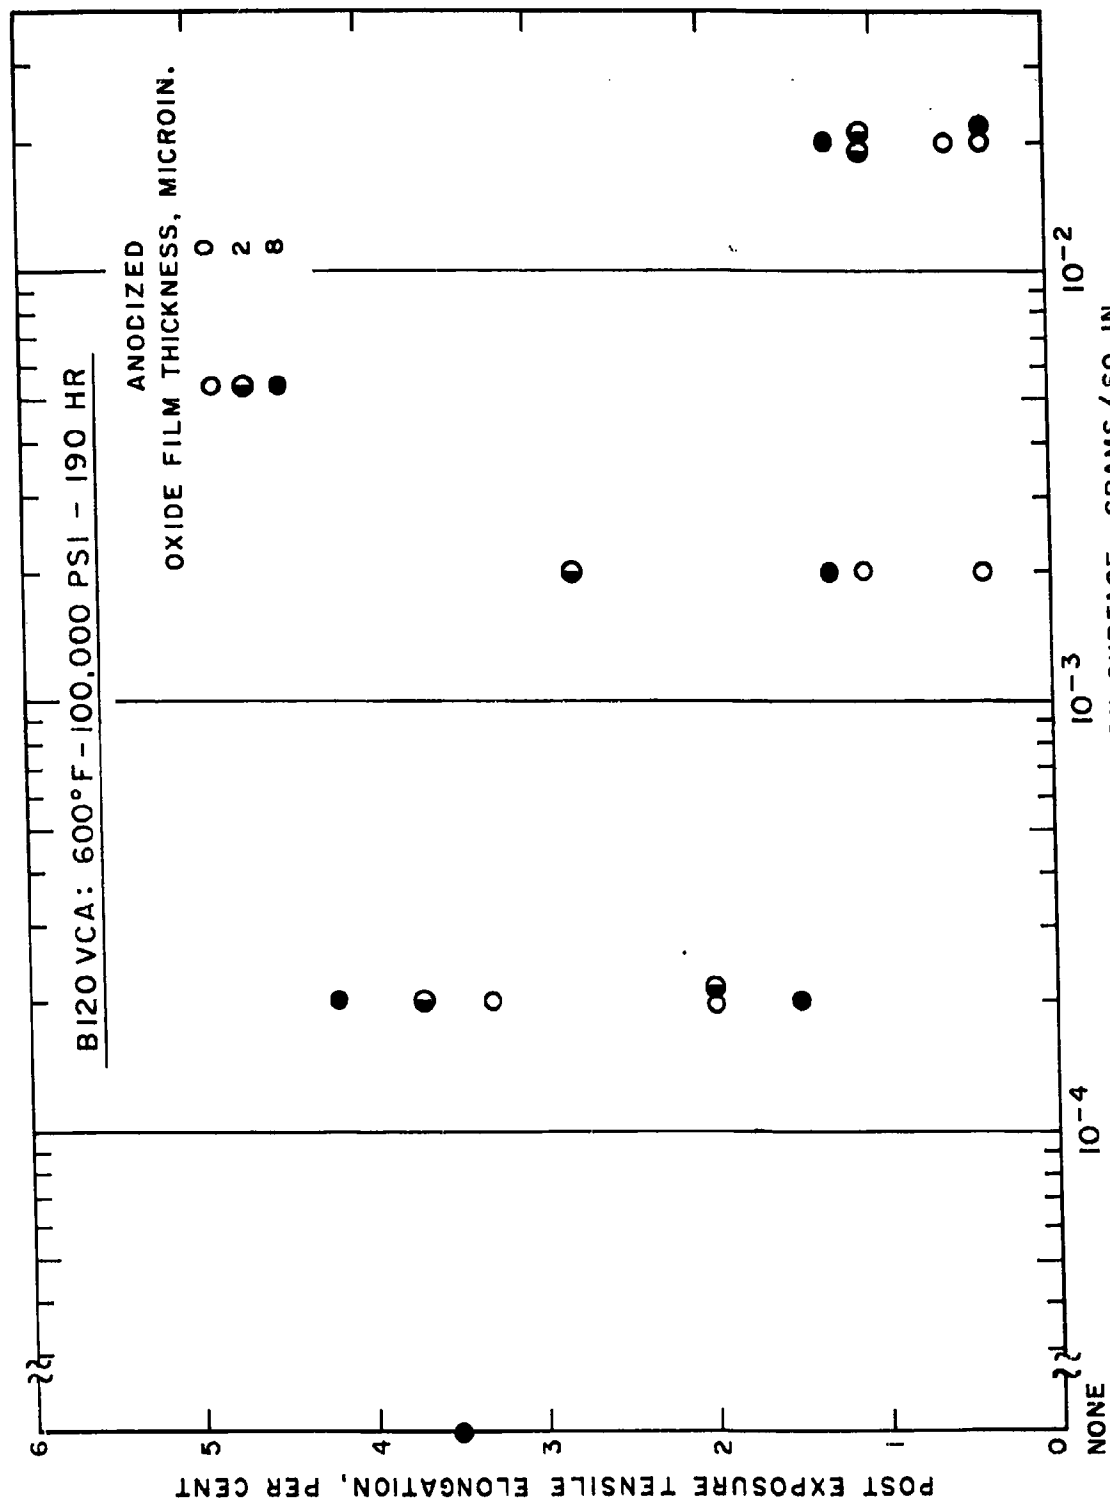
Figure 12 - Effect of Anodizing and Salt Concentration on the Stress Corrosion  
Of B-120 VCA Titanium Alloy at 600°F.

Figure 12 indicates that the B-120VCA alloy is susceptible to some extent even at the lowest salt level, and stress-corrosion damage increased with increased quantity of salt. The data suggest that the anodizing treatment may have been beneficial. However, the degree of protection afforded under the conditions of this evaluation was not very great.

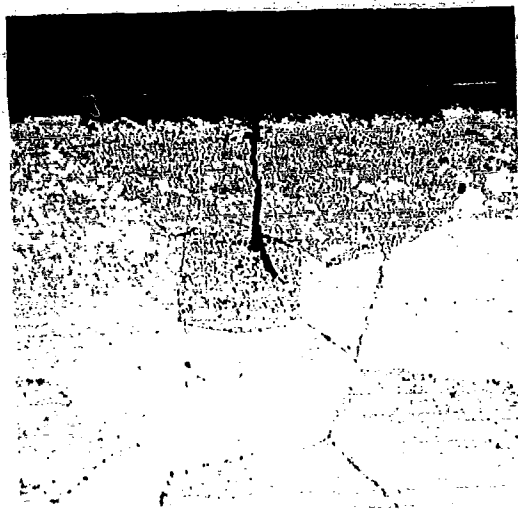
Fig. 13

B-12OVCA specimen No. C3, stress-corrosion crack due to exposure to 0.02 g/sq in. ASTM sea salt concentration at 600°F under 100,000 psi stress for 190 hr.

Metallographic examination of specimens exposed to the highest salt concentration showed the presence of transgranular stress-corrosion cracks in the unanodized specimen and in 2-microinch oxide film specimen. Excluding the crack from which the tensile fracture initiated, the metallographic sample from the former specimen contained 5 cracks of length varying from 0.002 to 0.004 in., while the sample from the latter specimen exhibited 17 cracks of

lengths varying from 0.002 to 0.007 in. No cracks were observed in the sample from the 8-microinch film specimen examined. The cracks exhibited very little branching and appeared to follow along crystallographic directions closest to being transverse to the stress axis. Examples of stress-corrosion cracks observed in the unanodized and in the 2-microinch anodized film specimens are shown in Figs. 13 and 14, respectively.

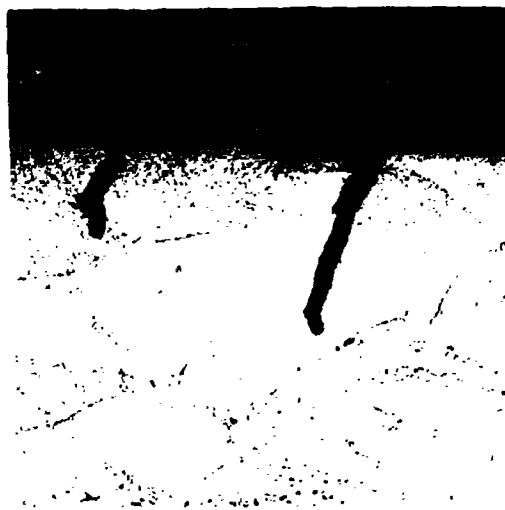
B-12OVCA specimen No. C6 with 2 micro-inch anodized film. Stress-corrosion cracks due to exposure to 0.02 g/sq in. ASTM sea salt concentration at 600°F under 100,000 psi stress for 190 hr.

Etchant: 20% conc. HF, 20% conc. HNO<sub>3</sub>, balance glycerine.

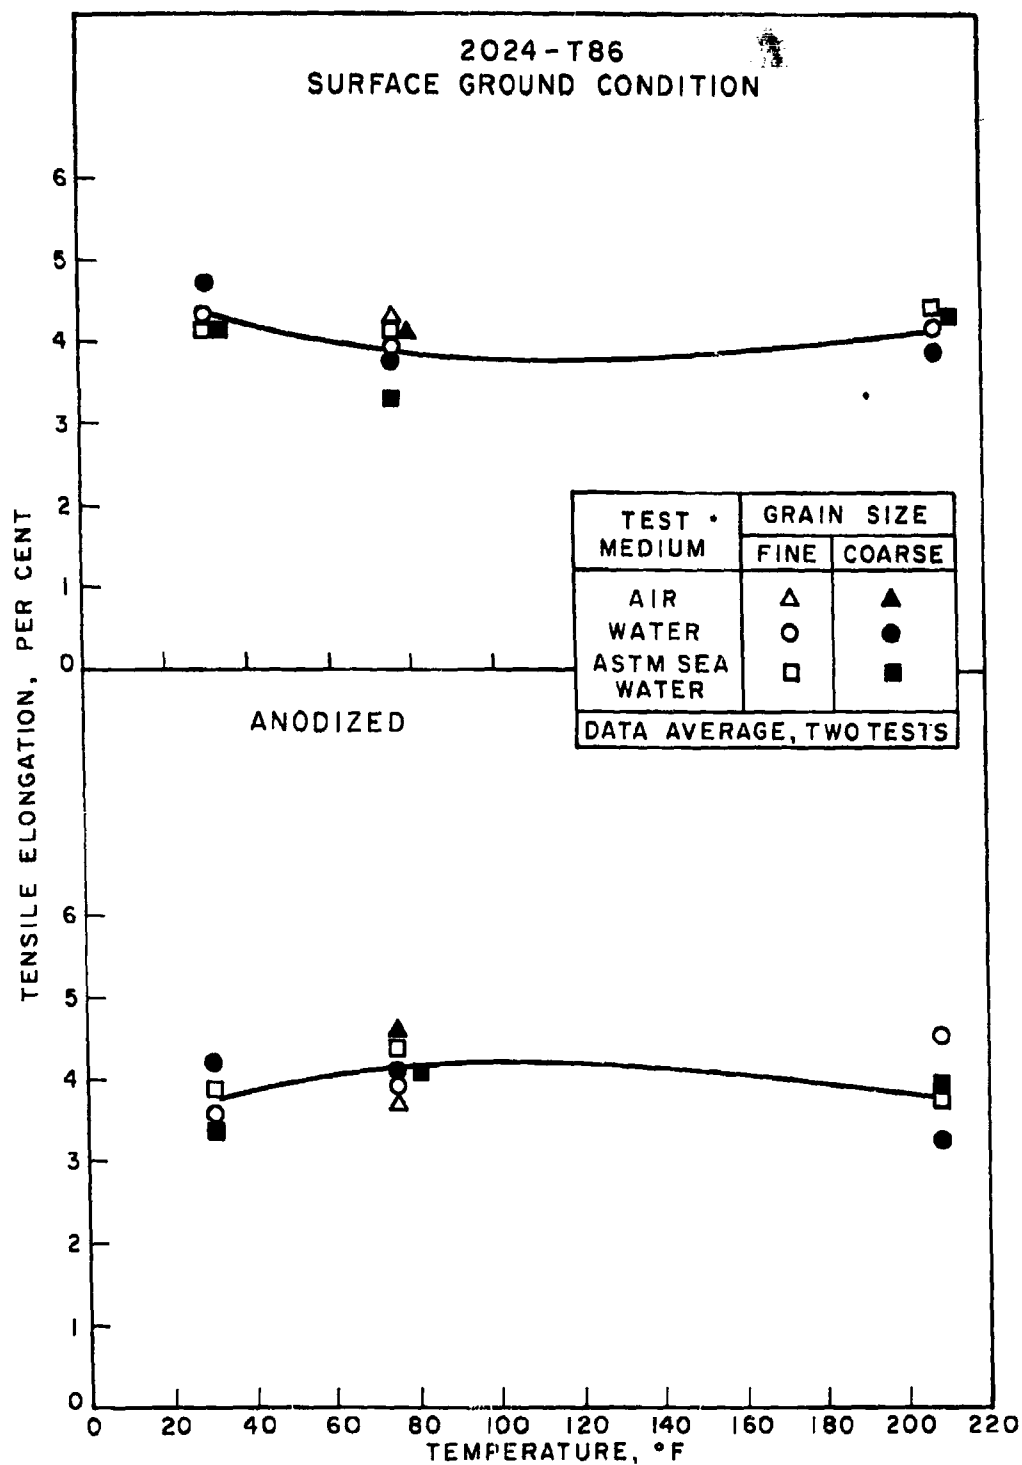
Fig. 17 - Tensile Elongation of 2024-T86 Aluminum Alloy for Tests in Various Media.

The data for tensile test in media of air, distilled water, and ASTM sea water at room temperature, and for the two aqueous media at 32° and 212°F are summarized in Tables 5 to 14. Tensile elongations as a function of temperature are plotted for each of five basic materials in Figs. 17 to 21. There was no significant change in the tensile properties of 2024-T86 for the variables imposed in this investigation. The 7075-T6 alloy similarly exhibited no tensile test property dependence on test medium, temperature or surface condition. It may be noted, however, that the grain-coarsened material had lower strength and higher ductility than the as-received material.

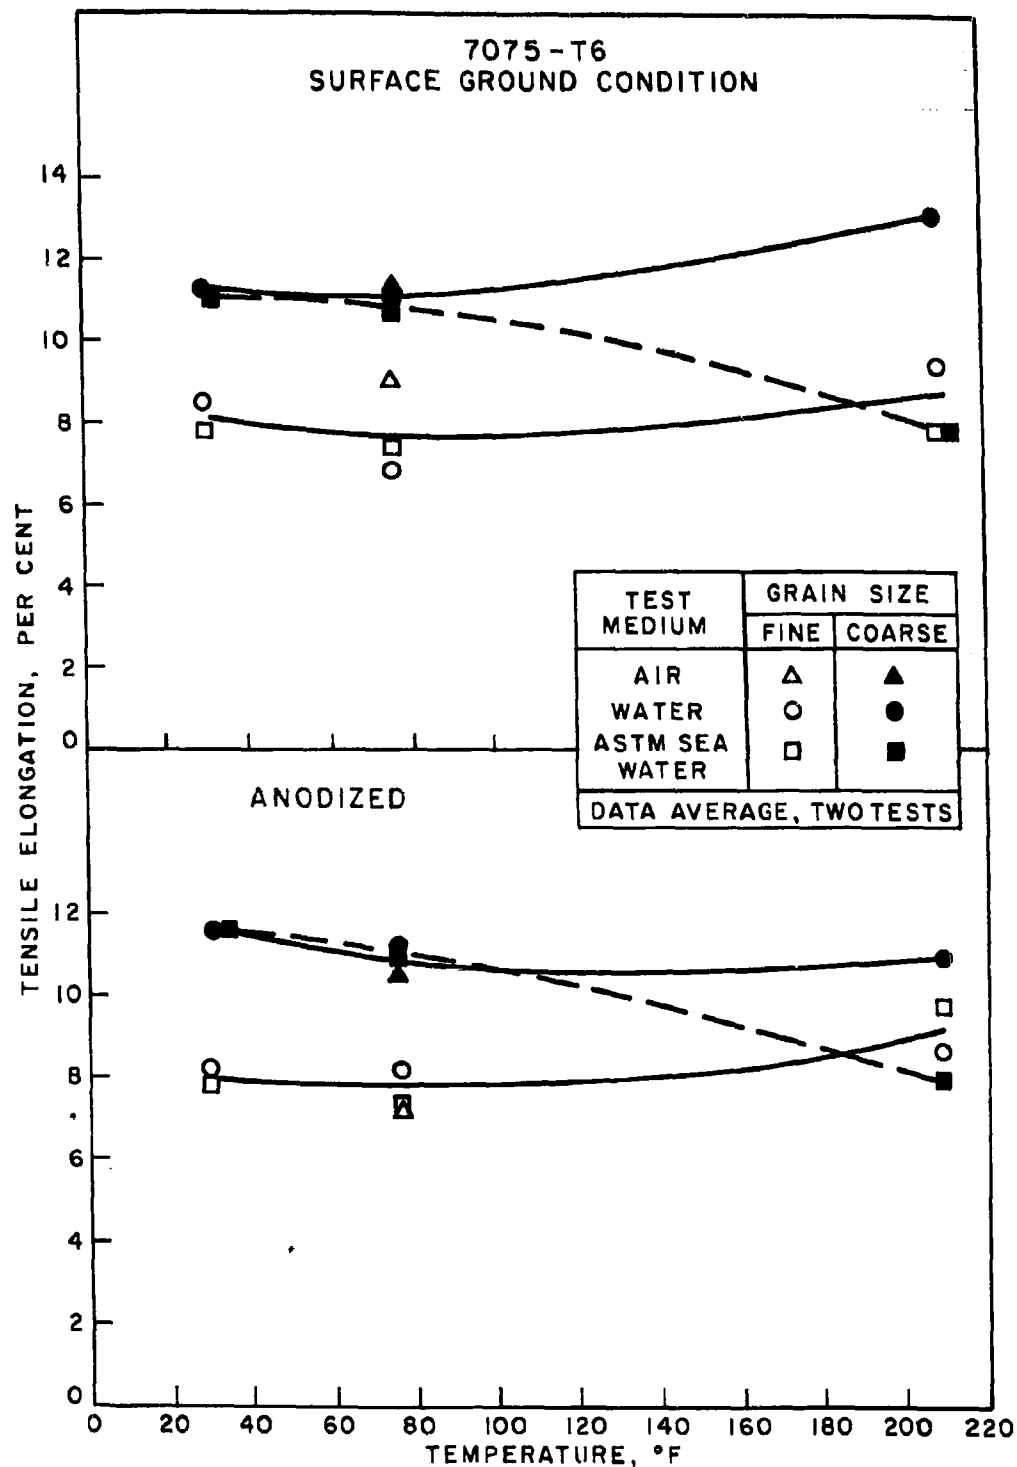
Fig. 18 - Tensile Elongation of 7075-T6 Aluminum Alloy for Tests in Various Media.

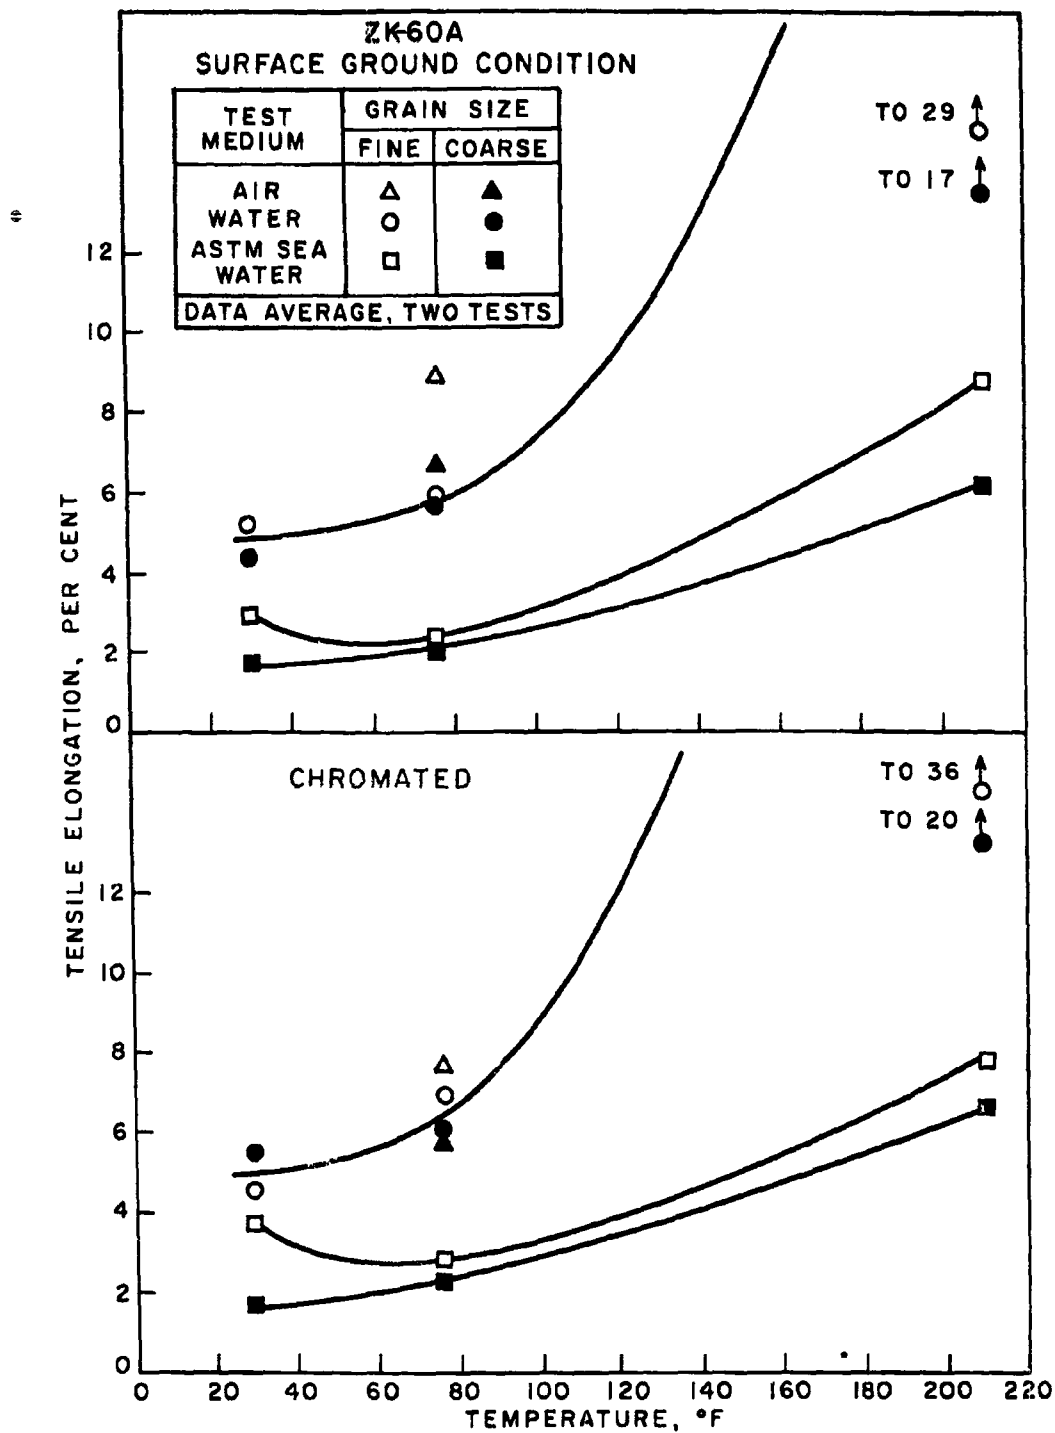
Fig. 19 - Tensile Elongation of ZK-60A Magnesium Alloy for Tests in Various Media.

The two surface conditions of the ZK-60A behaved similarly in the various media. Tests in air and water gave approximately the same results; the average elongation was somewhat higher for tests in air compared to tests in water. Tests in ASTM sea water resulted in lower elongation than testing in the other media; and comparing the aqueous media this difference increased with increasing temperature. The high elongations in water solution are due to the occurrence of stress-corrosion cracks throughout the reduced section. Chromating leaves a very rough surface on ZK-60A alloy, and cracks originate at the base of the deeper pits as shown by Fig. 22, which is a photomicrograph of a specimen tensile tested in air. Five such cracks were observed in the particular metallographic sample represented.

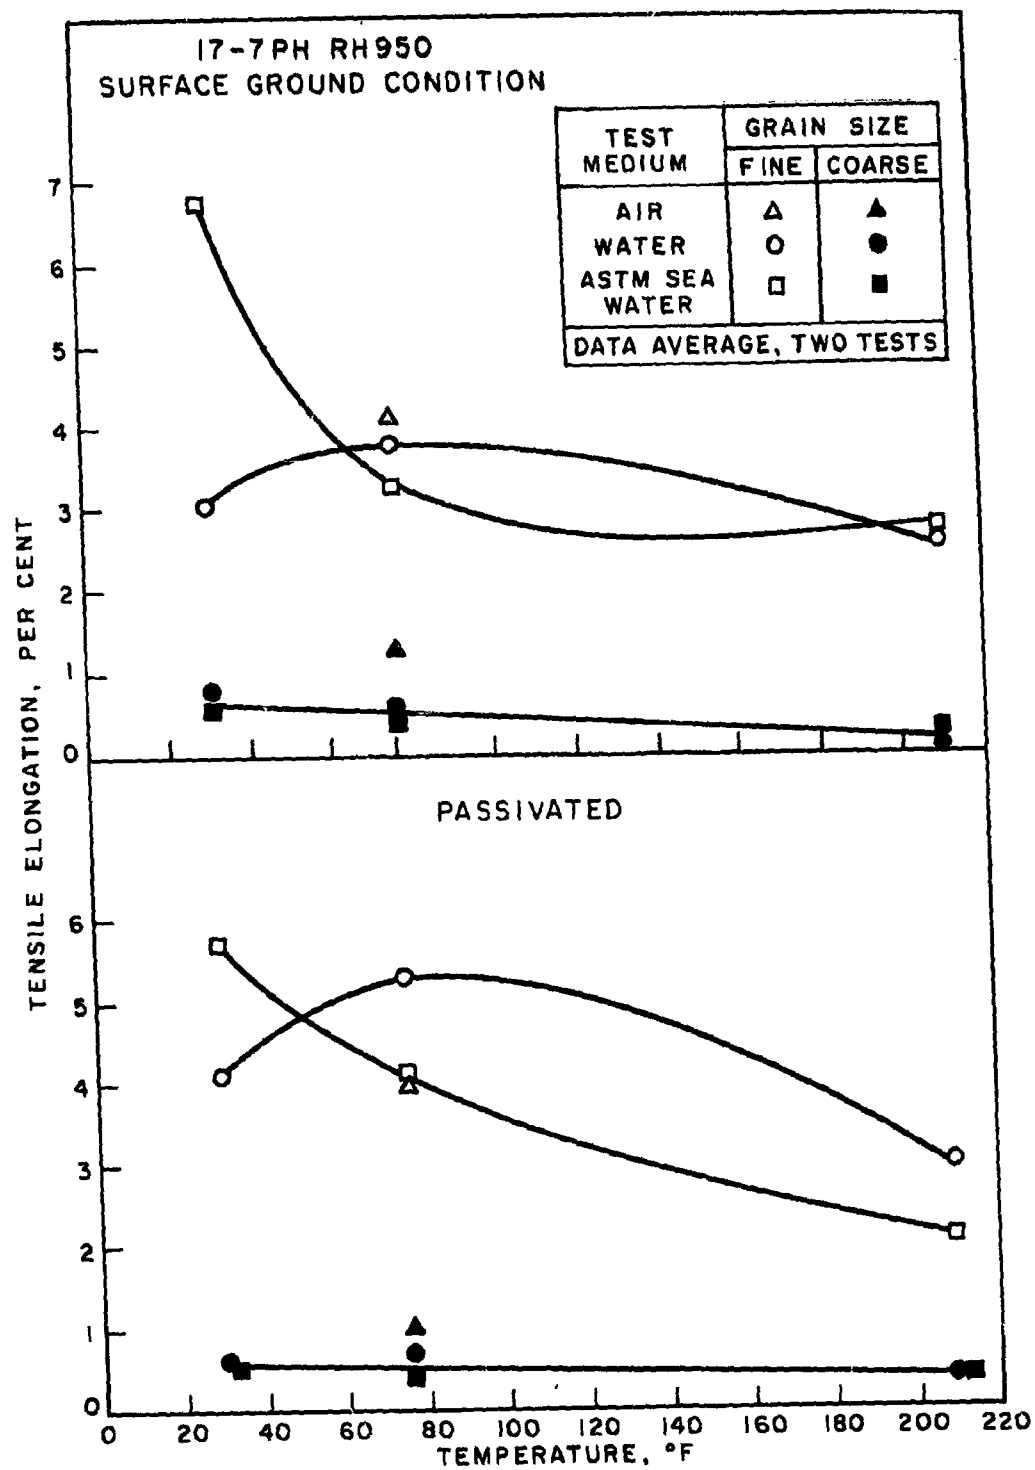
Fig. 20 - Tensile Elongation of 17-7PH RH 950 Stainless Steel for Tests in Various Media.

The grain-coarsening heat treatment of 2000°F for 4 hours was very detrimental to the tensile ductility of 17-7PH in the RH 950 condition, as shown by Fig. 20.\* This heat treatment which was done in air apparently caused grain boundary oxidation to a depth of about 0.001 in. as illustrated by Fig. 23. However, surface grinding to remove 3 mils and consequently the damaged layer from each surface produced a tensile elongation of 3.3% in one specimen but only 0.8% in another. It is possible that due to distortion 3 mils were not removed over the entire surface of the latter. Therefore, it appears that the damage was limited to the surface layers. In the as-received, fine-grain size condition the stainless steel exhibited somewhat higher elongation in ASTM sea water at 32°F than in distilled water. At room temperature this relationship is reversed but smaller in magnitude. There does not appear to be a significant difference at 212°F. In the grain-coarsened condition all tests in aqueous media produced tensile elongations of less than 1%, while tests in air at room temperature resulted in elongations of 1% or slightly more.

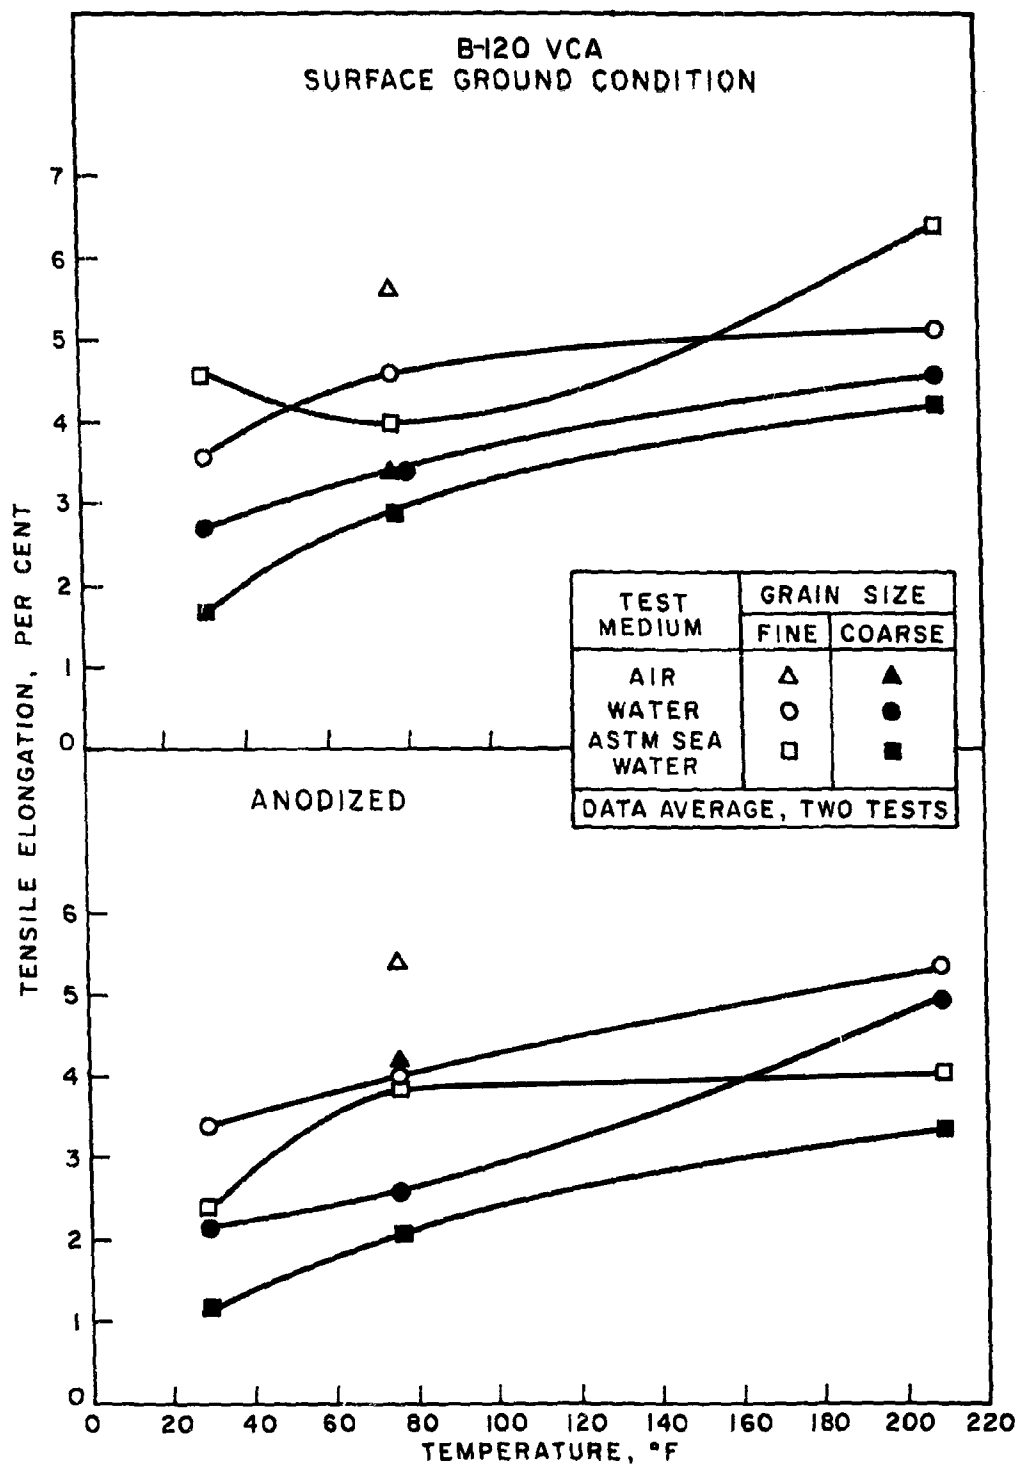
Fig. 21 - Tensile Elongation of B-120 VCA Titanium Alloy for Tests in Various Media.

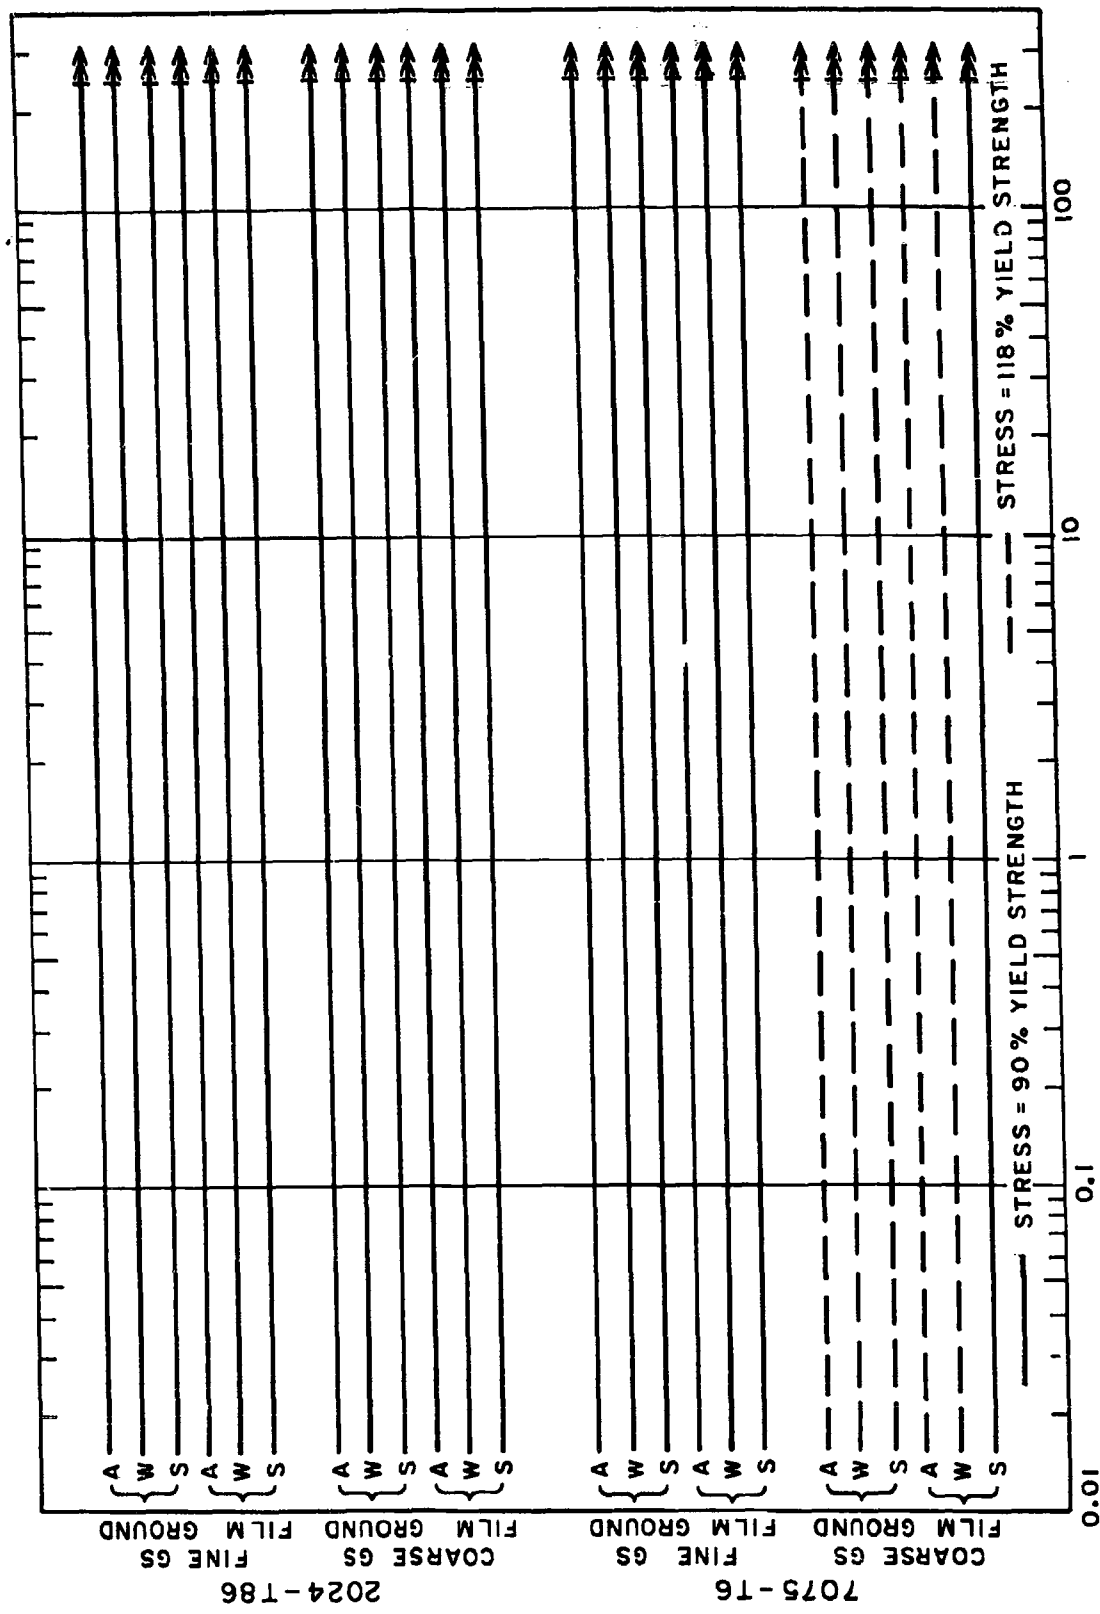
Fig. 24 - Summary of Results for Static Load Exposure of Aluminum Alloys 2024-T86 and 7075-T6 in Media of Air, Water, and ASTM Sea Water

The results of subjecting the test materials to loads of 90% yield strength (0.2% offset) in the presence of air, distilled water, and ASTM sea water for 240 hours are summarized in Tables 15 to 24, and Figs. 24 to 26. Occasionally there was a leak which necessitated interrupting the test in order to stop it. In such cases failure frequently occurred very soon after the reapplication of the load. Also, failures in the lower pin hole were very often associated with a leak condition. Tests in which leak conditions prevailed upon initial loading are so indicated in the tables. The term "interface" in the last column of some of the tables from No. 19 through 25 refers to the air/aqueous solution interface. All of the aluminum alloys specimens survived the exposures as shown by Fig. 24. Post-exposure tensile testing indicated that the fine-grained surface specimens and coarse-grained, anodized specimens of 2024-T86, and a coarse-grained, surface-ground specimen of 7075-T6 suffered damage as a result of the exposure in ASTM sea water. The coarse-grained 7075 alloy was inadvertently loaded to 118% of the yield strength rather than the intended 90%.

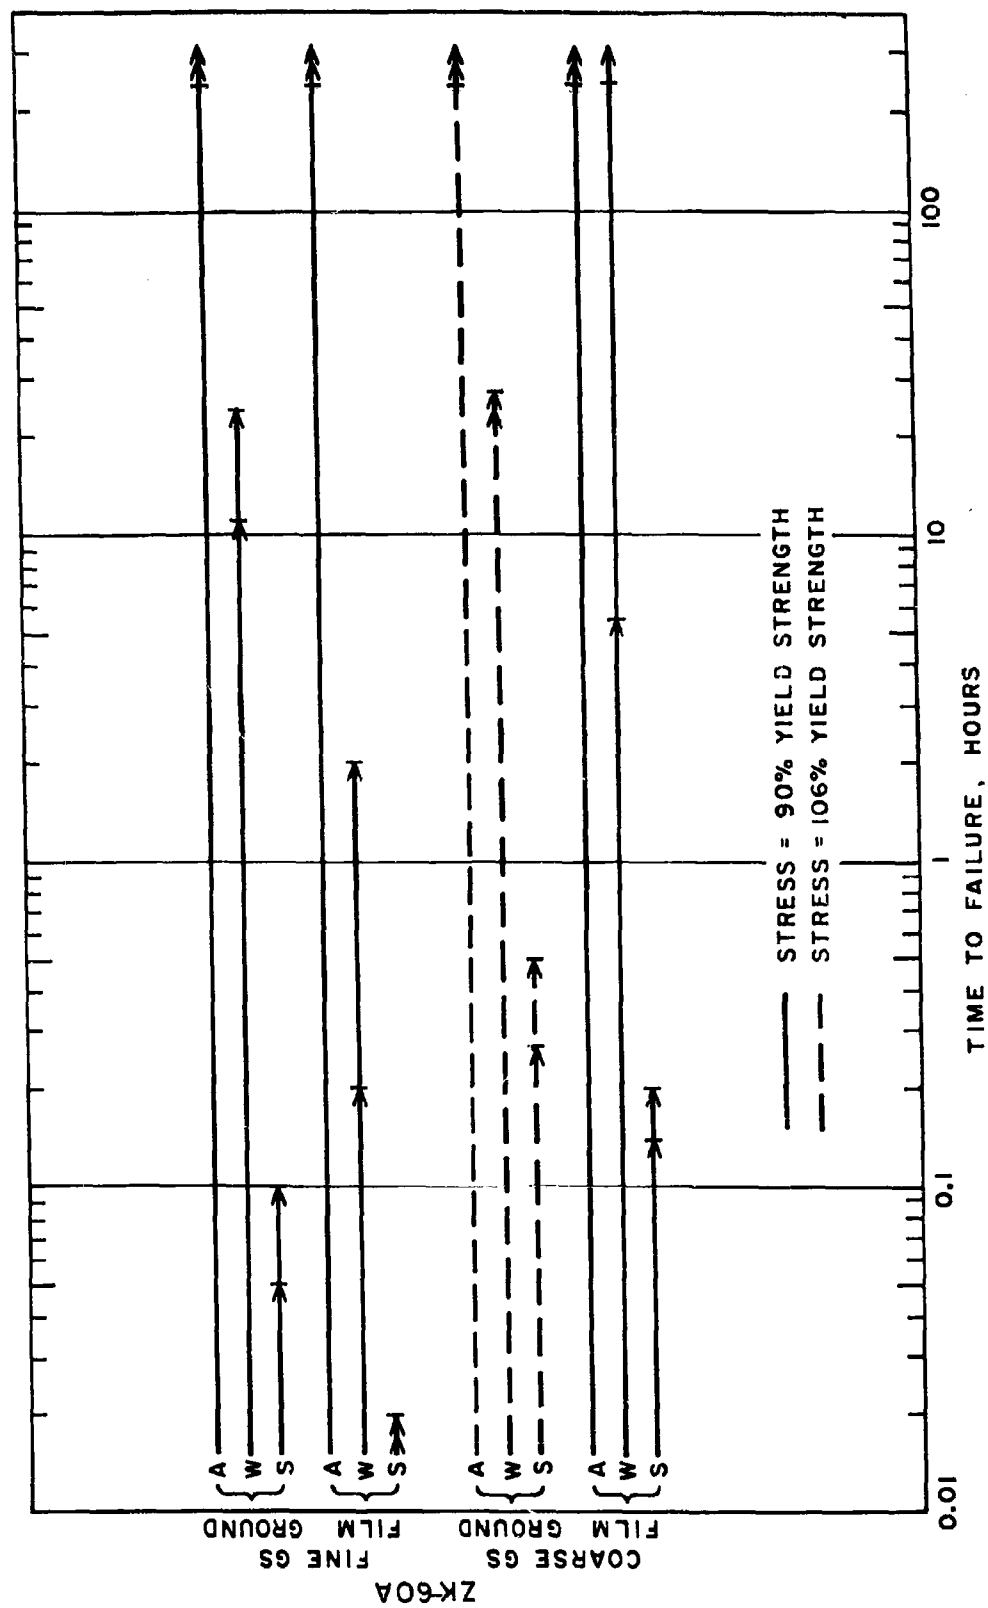
**Fig. 25 - Summary of Results for Static Load Exposure of ZK-60A in Media of Air, Water, and ASTM Sea Water**

Figure 25 and Tables 19 and 20 summarize the results for static load exposure in various media for ZK-60A alloy. The coarse-grained material in the surface-ground condition was inadvertently stressed to 106% of the yield strength rather than the intended 90%. The data suggest that the fine-grain, surface-ground condition is more resistant to stress-corrosion cracking in the aqueous media than the fine-grain, film condition; and the coarse-grain, film condition is more resistant to stress-corrosion cracking than either. The position of the coarse-grain, surface-ground condition is somewhat uncertain because of the unequivalent load; however, it appears to be on a par with the coarse-grain, film condition. Figure 27 shows a stress corrosion crack in a fine-grain, film condition specimen exposed to ASTM sea water.

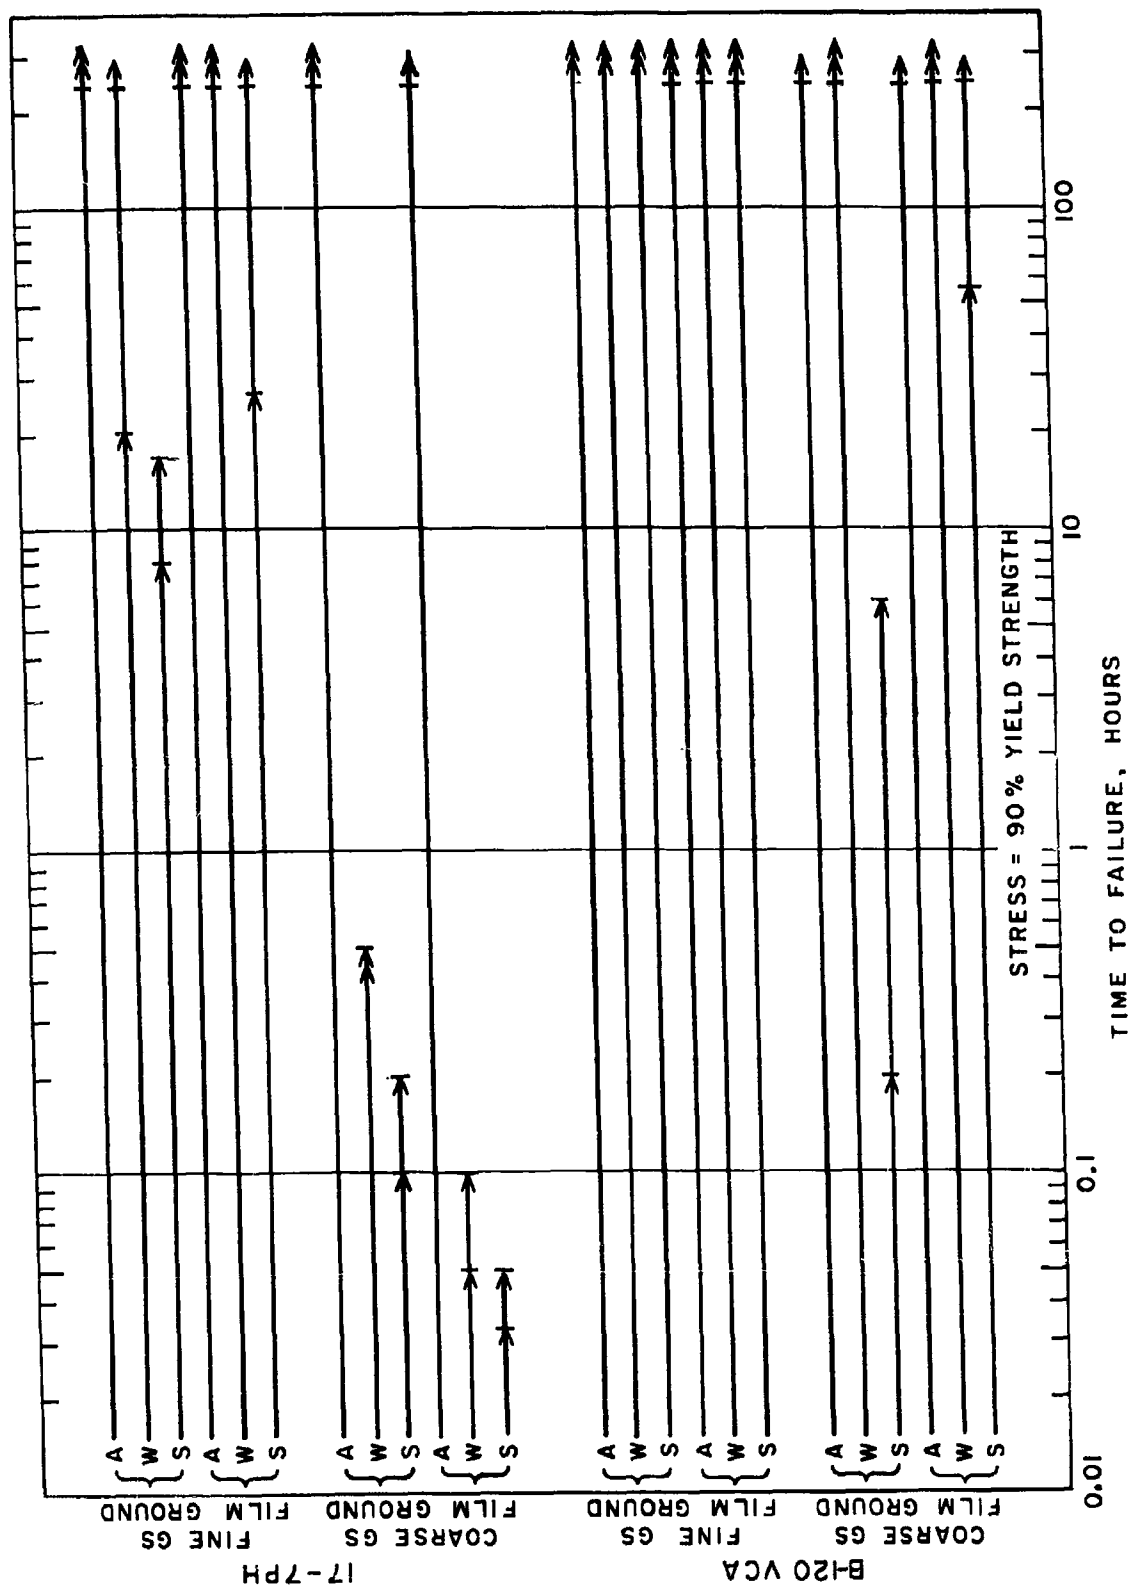
Fig. 26 - Summary of Results for Static Load Exposure of 17-7PH and B-120 VCA in Media of Air, Water, and ASTM Sea Water

Static load exposure results for 17-7PH are given in Fig. 26 and Tables 21 and 22. Failures during exposure occurred in water and ASTM sea water. Failures were more numerous in the coarse-grain material, and they occurred in much shorter times. The most frequent site of fracture was at the base of the container suggesting a concentration cell effect. Similar behavior was reported by Ault for AM-350 alloy (5). However, fracture at the air/solution interface was almost as frequent. The poorer performance of the coarse-grain material was very likely related to the surface condition discussed above.

Static load results for B-12OVCA are summarized in Fig. 26 and Tables 23 and 24. A number of specimens in the as-received (coarse grain) condition fractured in the pin hole, either during exposure or during subsequent tensile testing. Consequently when the fine grain material was machined to test specimens at some later time the width of the reduced section was changed from  $3/8$  to  $1/4$  in. The theoretical stress concentration of the pin hole was 2.4. Pin hole fractures during exposure were associated with the presence of aqueous solution. In the case of the surface-ground condition, specimens were entirely immersed in the medium for the grinding, and undoubtedly traces of solution remained in the pin holes. In the case of the film condition specimen (specimen No. 12), the container developed a leak which probably led to wetting of the lower pin hole where fracture occurred.

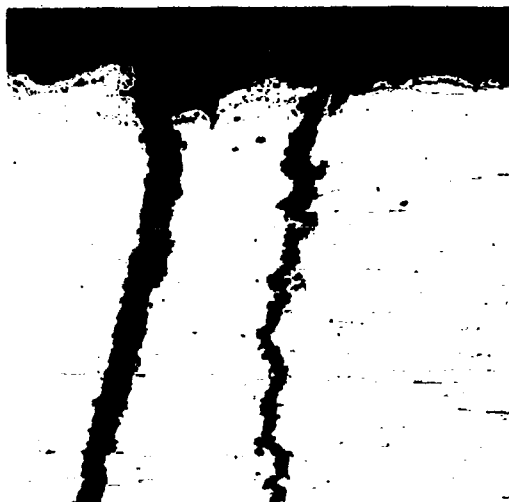
Fig. 27

ZK-60A stress-corrosion cracks in fine-grain chromated specimen which failed in ASTM sea water under a load of 90% of the yield strength in about 1 min.

Etchant: 60% ethylene glycol, 20 glacial acetic acid, 1% conc.  $\text{HNO}_3$ , balance distilled water.
